<u>Update2.3</u> Create new page 5 in **J-D Hoover 600 - 900 Data JD7 Hoover Round Motor Connections ( Alternative 520)**

# Maytag late model update

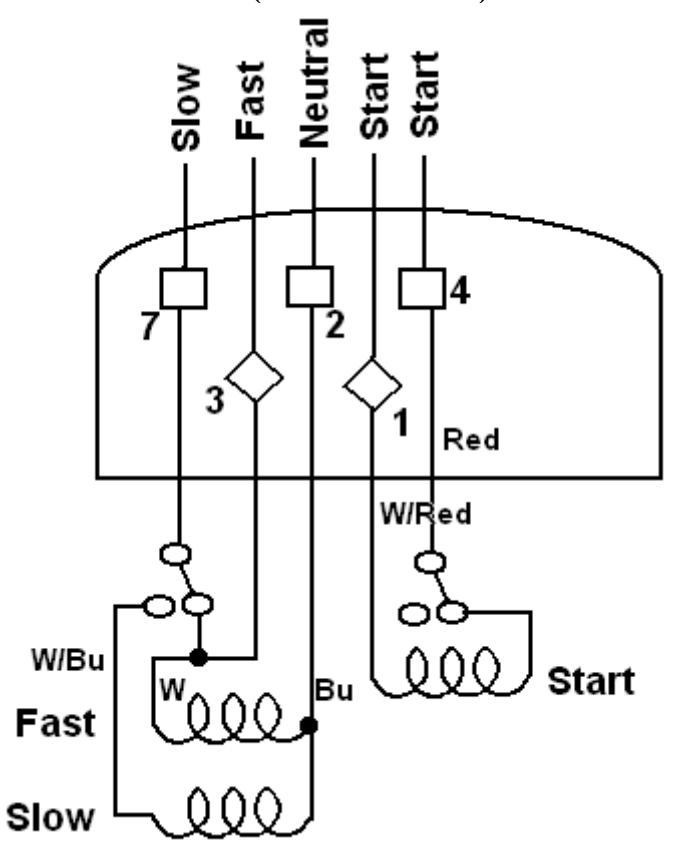
Illustration 1: Hoover alternative 520 Motor

- 1 Start Winding resistance Start 10 $\Omega$ , Fast 6 $\Omega$ , slow 9 $\Omega$
- 4 Start Round motor with internal switches, bush bearings
- 2 Neutral
- 3 Fast
- 7 Slow

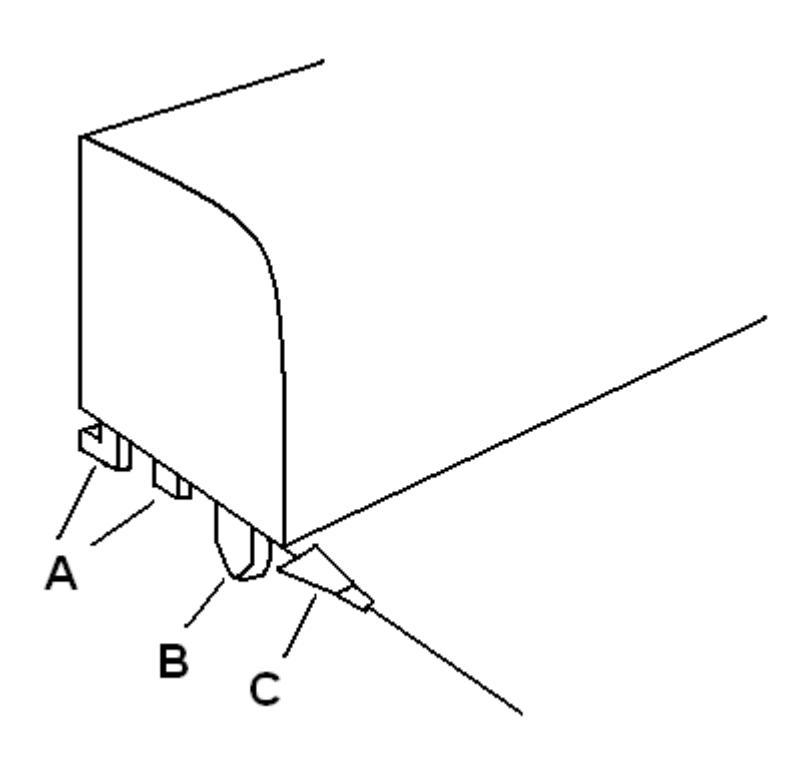
Illustration 2: Maytag Centennial Control Panel Access

Access to the control panel is like the Whirlpool, but instead of using screw they used a spring clip. Use a **thin** paint scraper to push the spring clip in as shown in illustration 3. This then allow the control panel to move forward and rotate up. (Like P3.1 and some other USA washers)

A = plastic lugs B = spring clip C = paint scraper

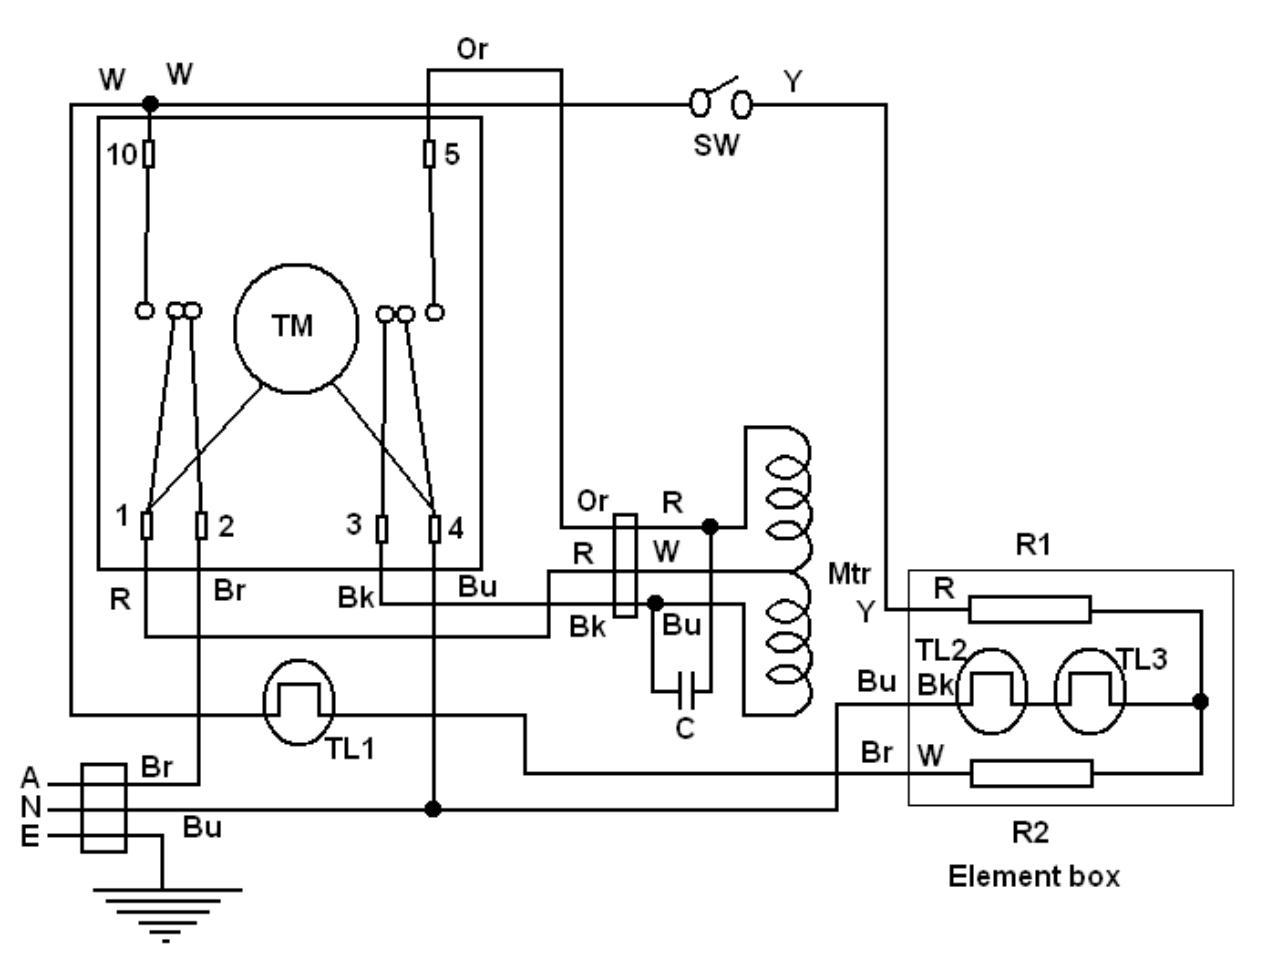
Illustration 3: New Simpson Dryer

*TM Timer Motor, Mtr Capacitor Run Motor, TL1 Thermostat in air tube/fan, TL2/3 Thermostat in element box, R1 68\Omega, R2 38\Omega, C Capacitor 8\muF*

Later models have a electronic controller with auto sensing. After replacing noisy motor bearings (6001) and testing the dryer would not heat. I wasted a lot of time checking the PCB and sensor only to discovered when run with out the sensor connected it would heat, it would also heat if used in time mode. Will it only heat when the sensor is damp, talking mate he say that the sensor/PCB are not reliable, and use the time mode. (Not a fix but a work around solution).
